Historic VICTORY BUILDING Retrofits Entrance and Lobby

IGHT YEARS AGO AMBICO Limited was approached by the owner of the stunning art deco Canadian federal government structure known as the Victory Building to design and manufacture retrofit doors at the entrance and lobby. The building, well-known in Winnipeg, Manitoba, was built in the 1930s in the midst of the Great Depression and has been situated in the downtown core of that provincial capital for 80 years. Its striking edifice was surely meant to inspire and support the local prairie community that was suffering economically at that time.

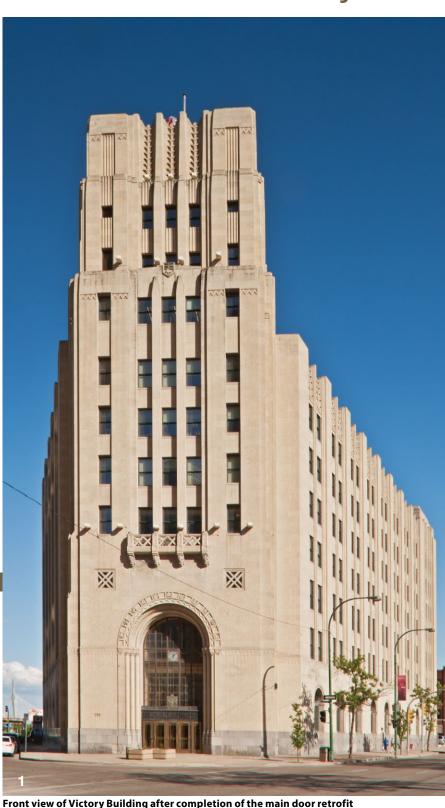
Front view of Victory Building after completion of the main door retrofit

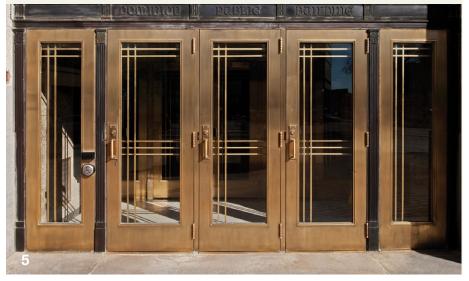
The interior bank of doors, frames, sidelites and hardware capture the beauty of the entranceway as seen from the main lobby looking outward.

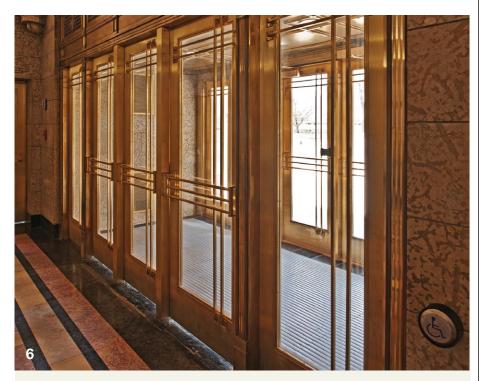
This photo demonstrates the care and precision required in the installation of the architectural hardware designed for the two banks of doors at the main entrance of the building.

As a result of the exactness required in its installation, the door hardware was factory pre-installed by the skilled workers at AMBICO's factory. Photo #7 shows the layout for the hardware installation in the AMBICO factory on one of the front

entrance doors. It clearly demonstrates the care necessary and the level of precision required for this type of hardware installation and is indicative of the attention to detail that is required to meet the unique demands of a project such as this.
